Analyzing Your NVT using GIS

Ver. 1.2.1 – June 5, 2024

Scott G. Fraser, CFM – scott@scottfraser.org

A Quick-Start Guide for the Uninitiated

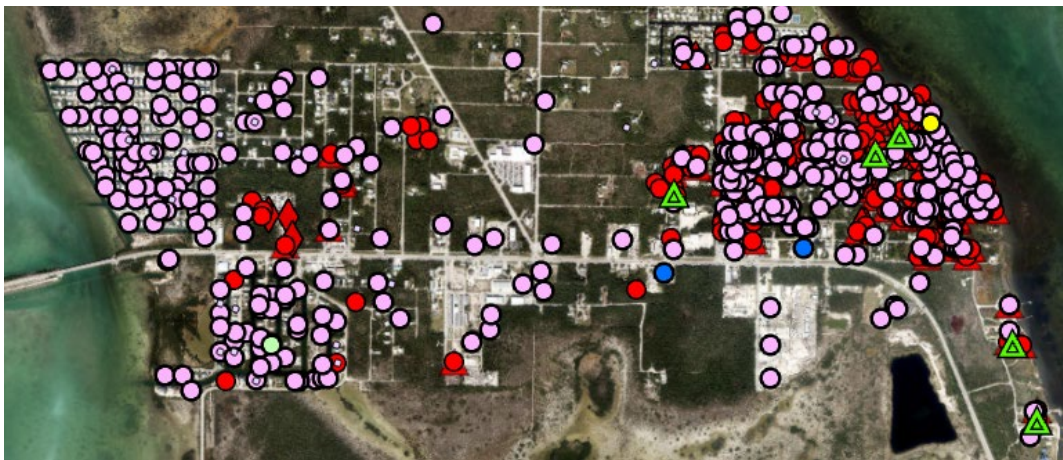
Figure 1 This GIS map example shows spatially located elevation certs, floodproofing certs, LOMAs, substantially damaged buildings, 1316 Declarations.

Auto-plotting points in bulk tends to place them all at the parcel's dead-center. This can cause points to become stacked under each other and hidden from view. It helps to employ an offset, so the points remain within the correct parcel but not under each other.

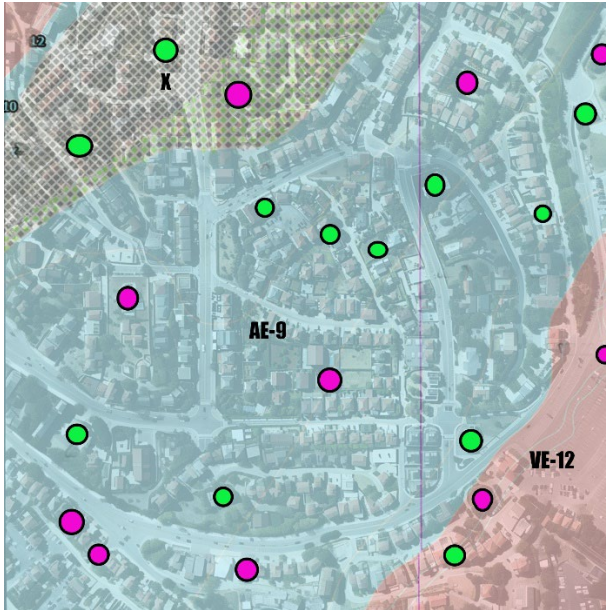
The green points have been vetted, categorized and/or resolved; with review still needed for the purple NVT points.

As you resolve the individual NVT listings, those points will change color, easily distinguishing between what’s finished and which remain. In this example, the green points have been vetted, categorized and/or resolved; with review still needed for the purple NVT points.

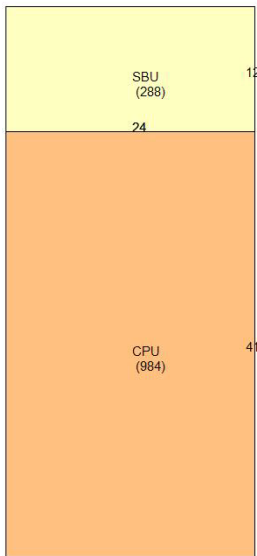
Building sketches from taxing agencies are a good reference for quickly triaging NVT listings. In this example, the ground level has an open carport area (CPU, orange), and is accompanied by at 288-sf utility enclosure (SBU, yellow).

Since the enclosure is less than the current maximum of 299-sf, the NVT concern is likely related to inadequate flood ventilation.

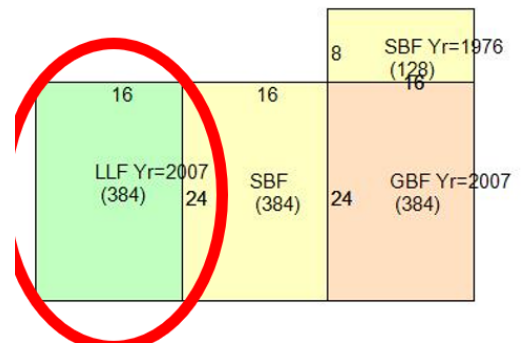
In this post-FIRM example, there are four separate enclosures at ground level: Garage, tan; two utility enclosures, yellow; living space, green.

Depending upon the year of construction compared to the floodplain ordinances in effect at the time, four enclosures of this size may have been permissible; yet habitable space wouldn't have been permissible. The follow-up necessitates an archives search to learn what was permitted and when.

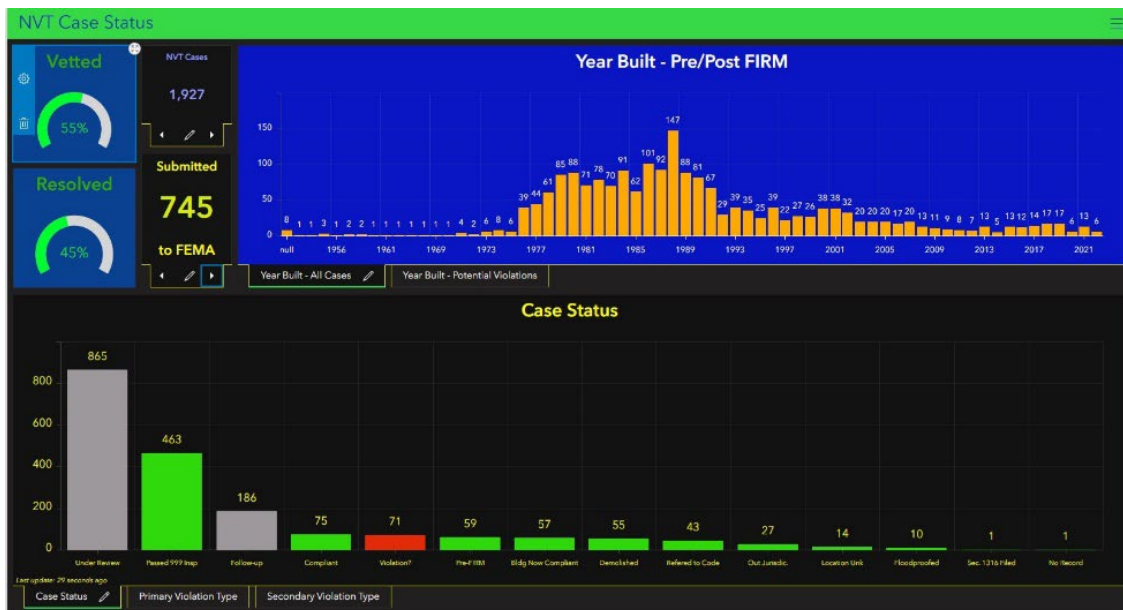
Once a dashboard has been setup, it's updated in real-time as your GIS data entries are made. A combination of gauges, indicators and charts can be customized to your needs. Related sub-charts become visible when clicking on the sub-tabs immediately beneath some of the charts.

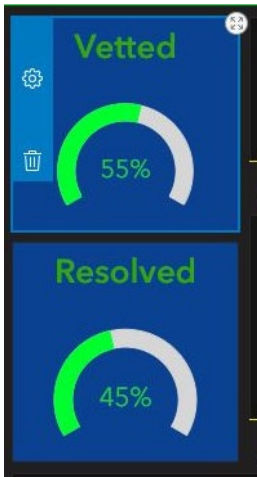
The “Vetted” and “Resolved” gauges are handy progress meters.

This pair of gauges shows triaging of the NVT listings is more than halfway done (55%). Of those reviewed so far, there was enough information to categorize 45% of the likely resolutions.

So far, only 10% need will require follow-up efforts.

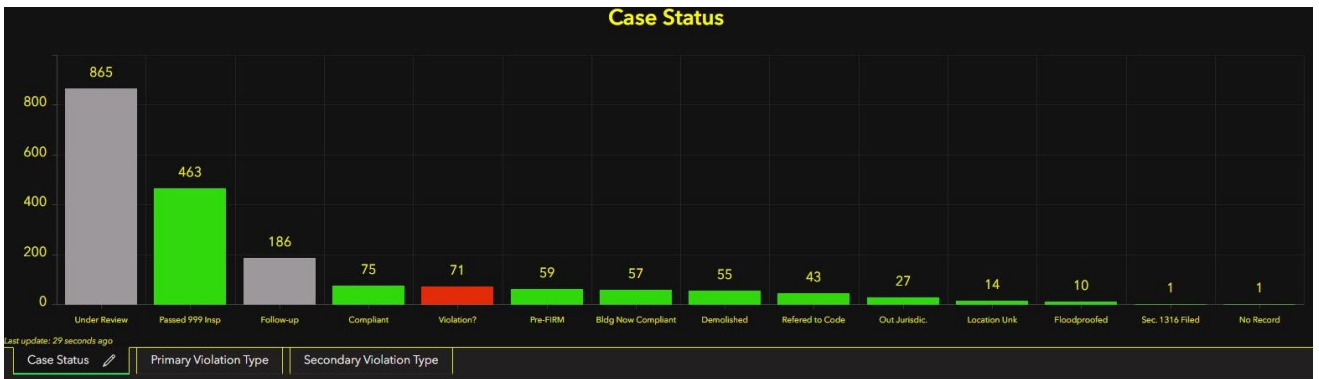
The case status chart shows individual counts of each status category. (see Status Categories)

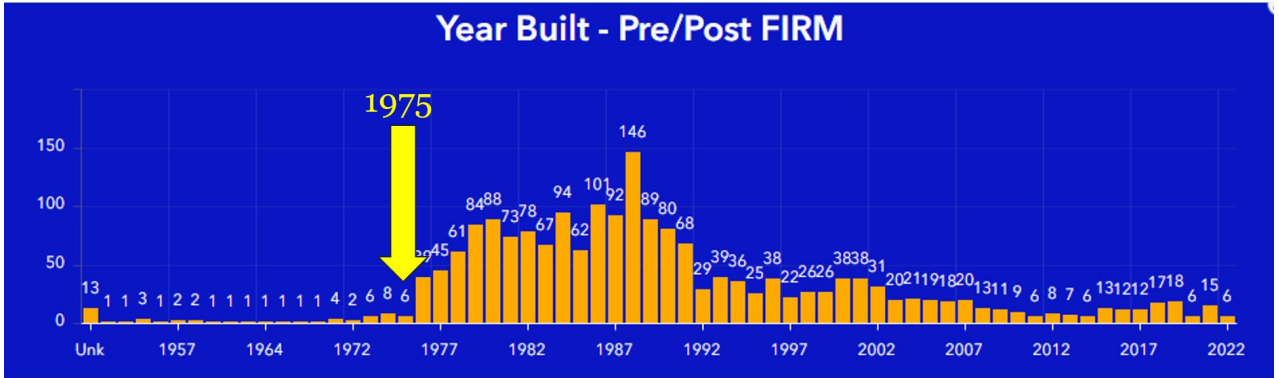
The year-built chart uses the property appraiser’s construction date (Certificate of Occupancy date) to age the NVT structures. The pre-FIRM date (12/31/1974) for many communities is indicated by the yellow arrow. Initially the ‘violation’ listings for 1975 and 1976 were much higher, yet research disclosed a number of those completed buildings involved pre-FIRM permits and thus should be removed from the NVT.

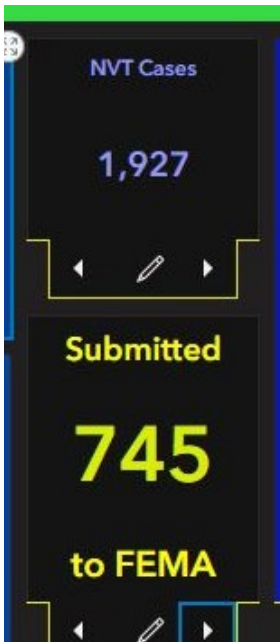
These indicators simply show the number of NVT listings followed by the number of resolutions submitted to FEMA to date.

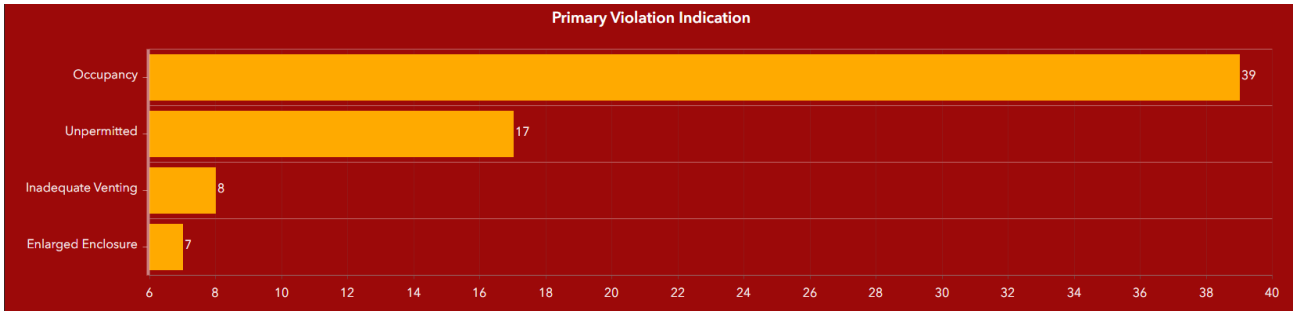
A sub-chart of potential floodplain violations further categorizes them by apparent cause to help define the scope of follow-up needed.
