# Analyzing Your NVT using GIS

## A Quick-Start Guide for the Uninitiated

A step-by-step guide showing one floodplain manager’s approach with using GIS to analyze, report and track its list of supposed floodplain violations appearing on FEMA’s new National Violations Tracker (NVT). The author is fully responsible for this content, which isn’t endorsed by any governmental agency. Anyone is free to duplicate and share this content when in the interest of improved floodplain management. The map appearing on the cover represents a fictional neighborhood created using artificial intelligence.

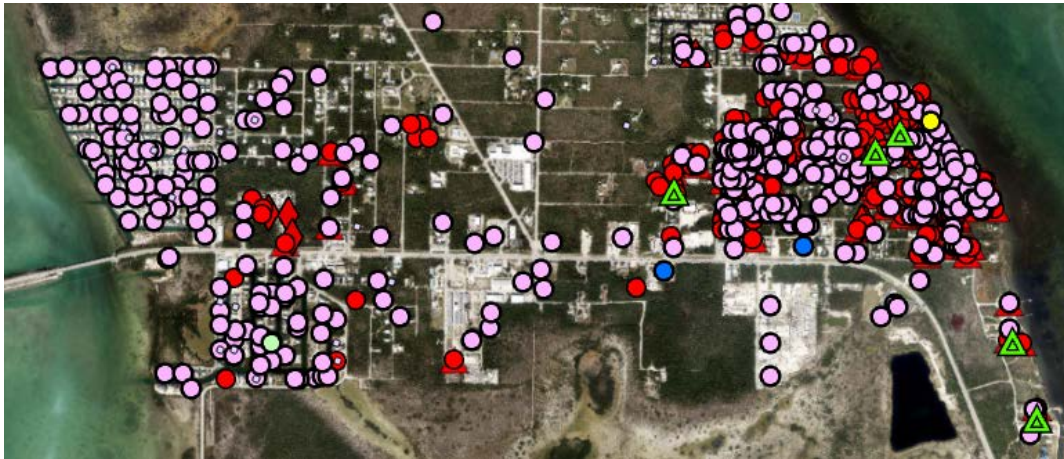
*Figure 1 This GIS map example shows spatially located elevation certs, floodproofing certs, LOMAs, substantially damaged buildings, 1316 Declarations.*

Auto-plotting points in bulk tends to place them all at the parcel's dead-center. This can cause points to become stacked under each other and hidden from view. It helps to employ an offset, so the points remain within the correct parcel but not under each other.

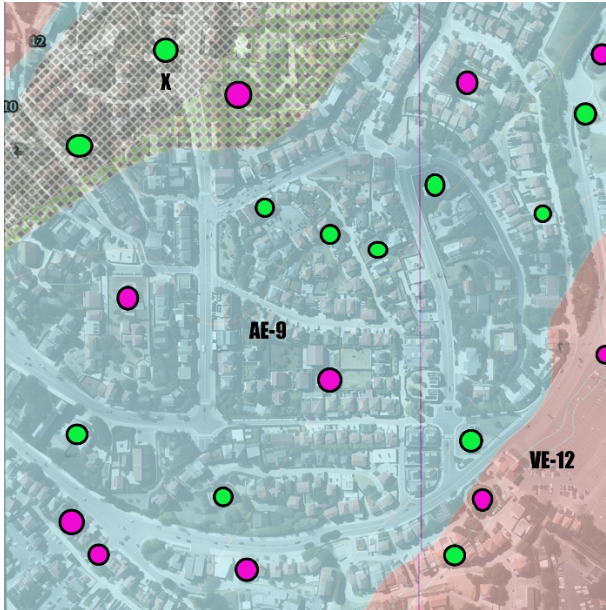
As you resolve the individual NVT listings, those points will change color, easily distinguishing between what's finished and which remain. In this example, the green points have been vetted, categorized and/or resolved; with review still needed for the purple NVT points.

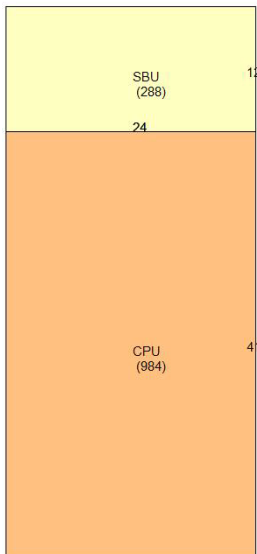
Building sketches from taxing agencies are a good reference for quickly triaging NVT listings. In this example, the ground level has an open carport area (CPU, orange), and is accompanied by at 288-sf utility enclosure (SBU, yellow).

Since the enclosure is less than the current maximum of 299-sf, the NVT concern is likely related to inadequate flood ventilation.

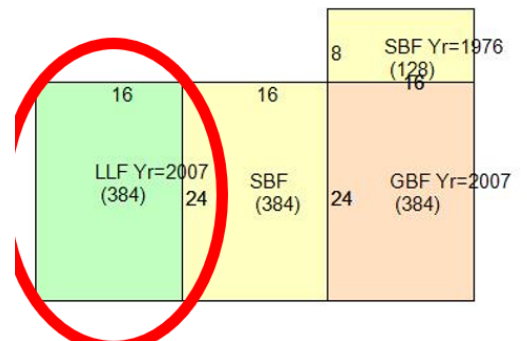
In this post-FIRM example, there are four separate enclosures at ground level: Garage, tan; two utility enclosures, yellow; living space, green.

Depending upon the year of construction compared to the floodplain ordinances in effect at the time, four enclosures of this size may have been permissible; yet habitable space wouldn't have been permissible. The follow-up necessitates an archives search to learn what was permitted and when.

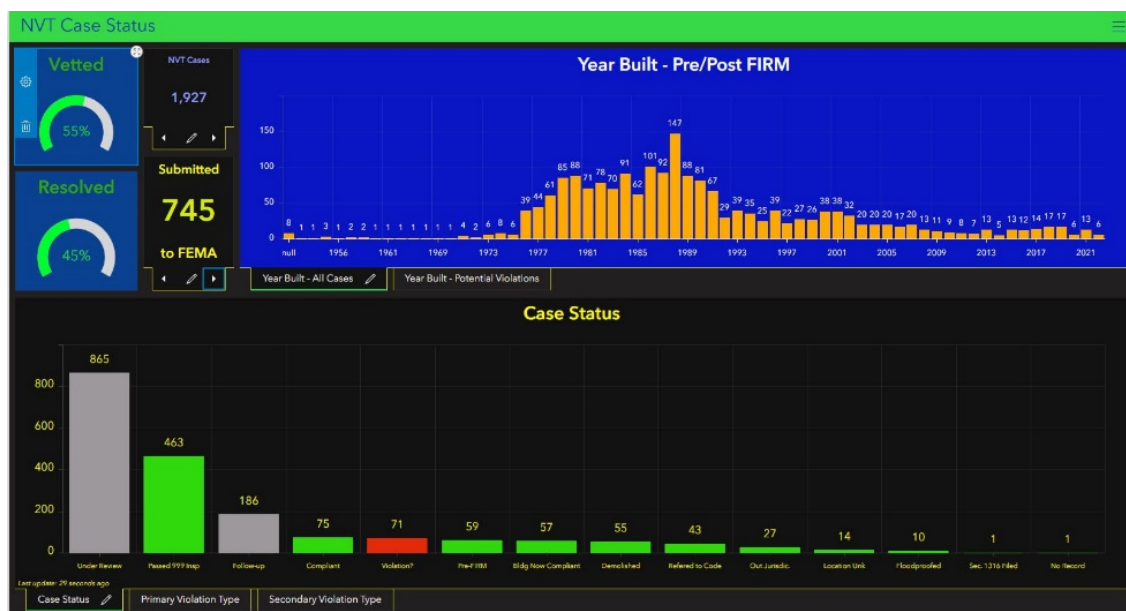
Once a dashboard has been setup, it's updated in real-time as your GIS data entries are made. A combination of gauges, indicators and charts can be customized to your needs. Related sub-charts become visible when clicking on the sub-tabs immediately beneath some of the charts.

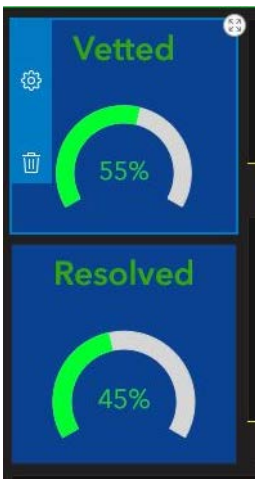
The “Vetted” and “Resolved” gauges are handy progress meters.

This pair of gauges shows triaging of the NVT listings is more than halfway done (55%). Of those reviewed so far, there was enough information to categorize 45% of the likely resolutions.

So far, only 10% need will require follow-up efforts.

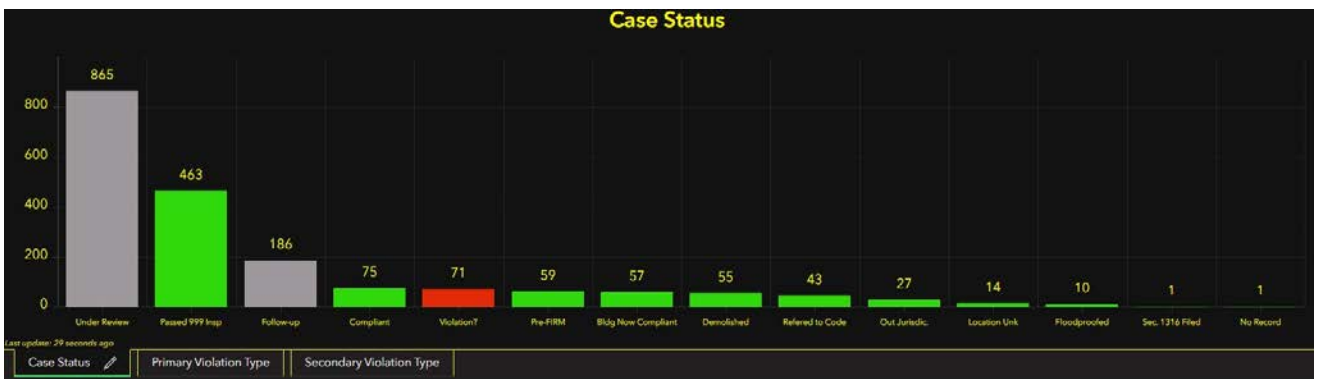
The case status chart shows individual counts of each status category. (see Status Categories)

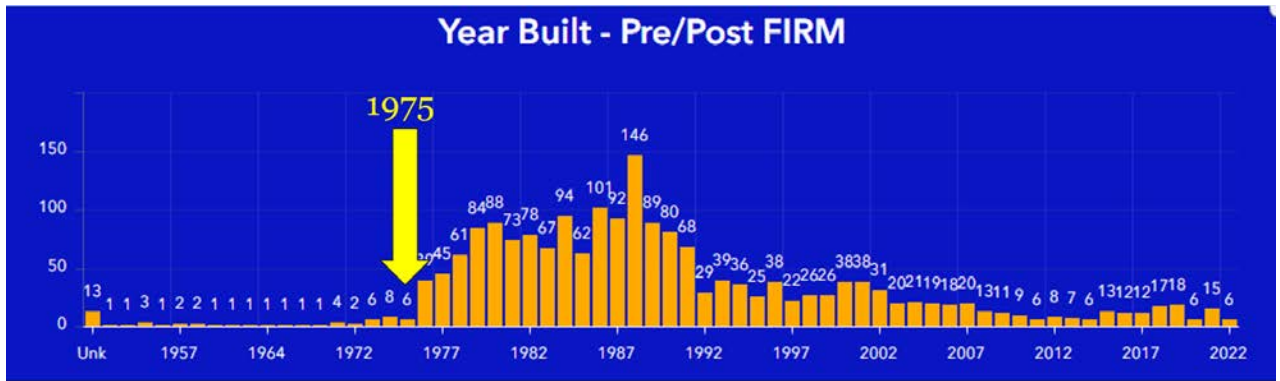
The year-built chart uses the property appraiser’s construction date (Certificate of Occupancy date) to age the NVT structures. The pre-FIRM date (12/31/1974) for many communities is indicated by the yellow arrow. Initially the ‘violation’ listings for 1975 and 1976 were much higher, yet research disclosed a number of those completed buildings involved pre-FIRM permits and thus should be removed from the NVT.

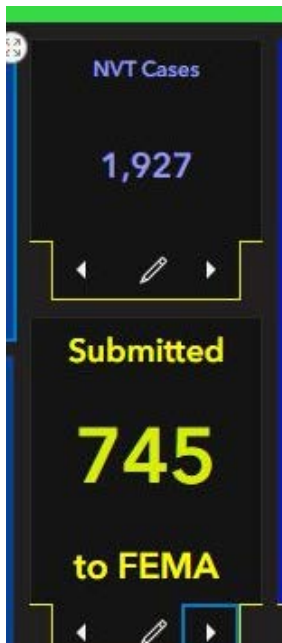
These indicators simply show the number of NVT listings followed by the number of resolutions submitted to FEMA to date.

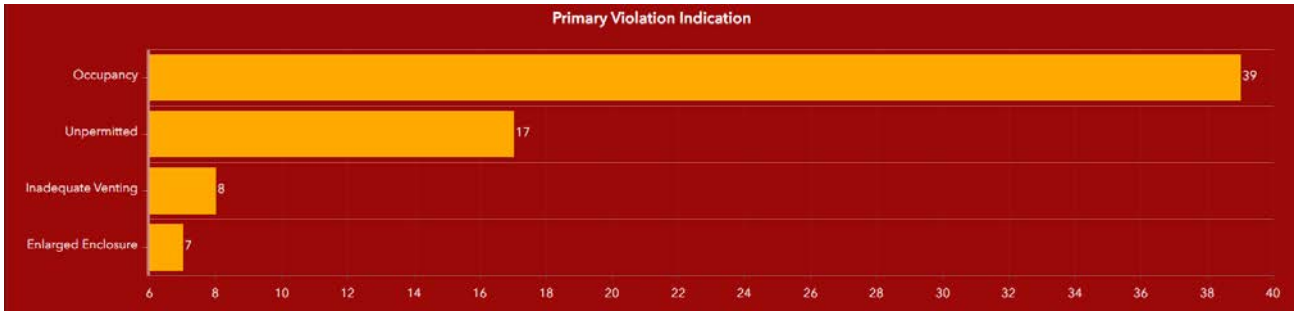
A sub-chart of potential floodplain violations further categorizes them by apparent cause to help define the scope of follow-up needed.
